Test Report : Chilt/RF08014

**A fire resistance test performed on a double leaf
single acting doorset with glazing**

**Test conducted in accordance with BSEN 1634-1: 2000
and BSEN 1363-1: 1999**

**Mann McGowan Fabrications Ltd
Unit 4, Brook Trading Estate
Deadbrook Lane
Aldershot
Hampshire
GU12 4XB**

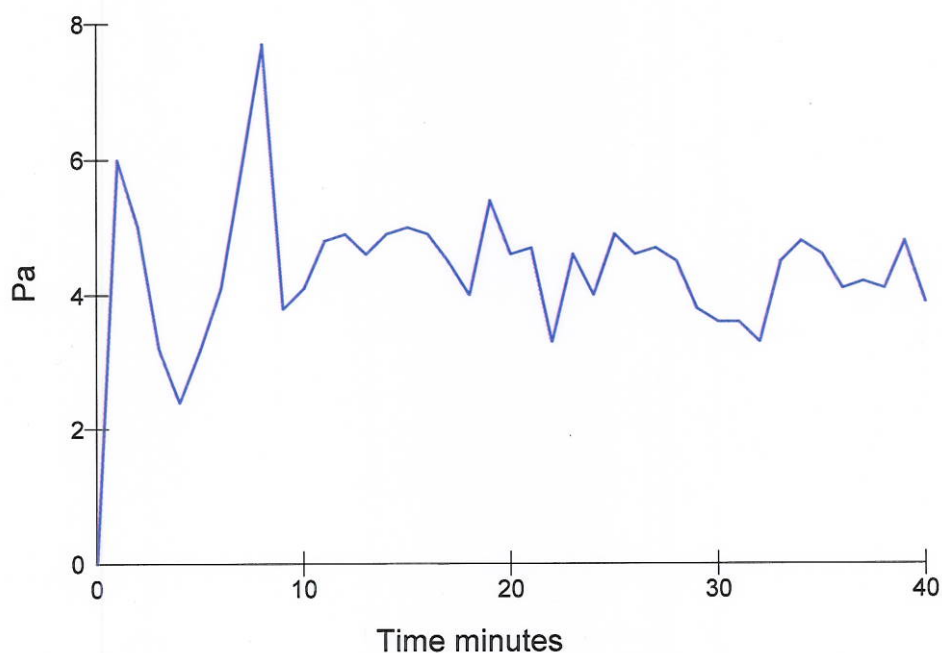
After the first 5 minutes of the test, the furnace pressure was maintained at 0 ± 5 Pa and after 10 minutes was maintained at 0 ± 3 Pa with respect to atmosphere, at a point 0.5m from the notional floor level. (The pressure was measured at a position 1m above the notional floor level which equates to a recorded reading of +4.25 Pa to produce the desired 0 Pa at a position 0.5m lower down.) The pressure readings have been tabulated in Appendix 1 and are shown graphically below:

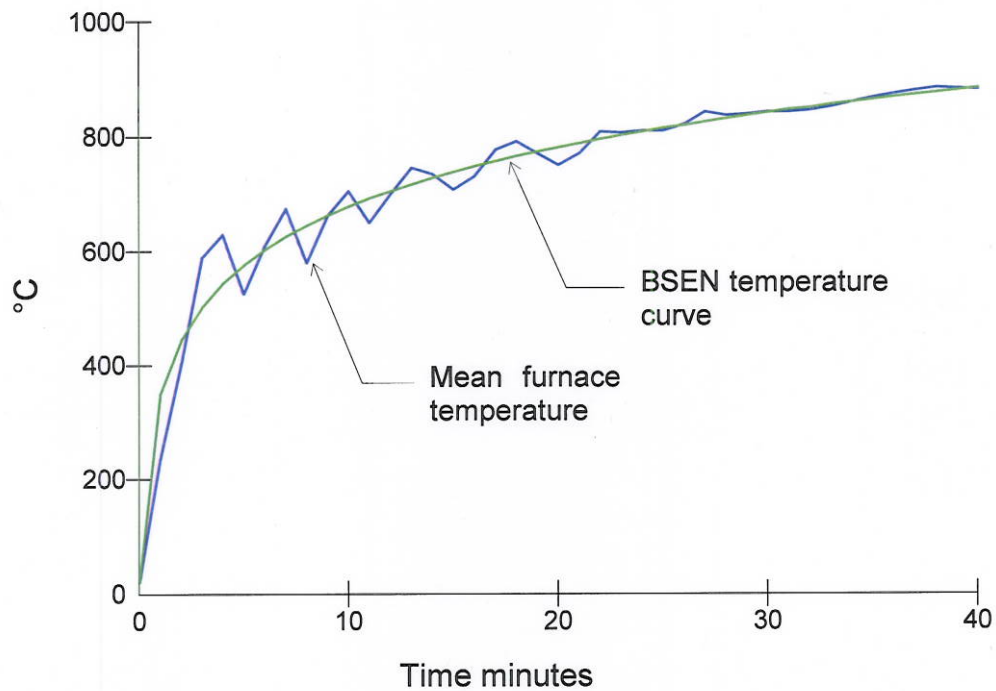
The furnace was controlled to follow the temperature/time relationship specified in BSEN 1363: Part 1: 1999 Section 5.1.1 as closely as possible, using the average of six plate thermometers suitably distributed within the furnace. The temperatures recorded have been tabulated in Appendix 1 and are shown graphically below:

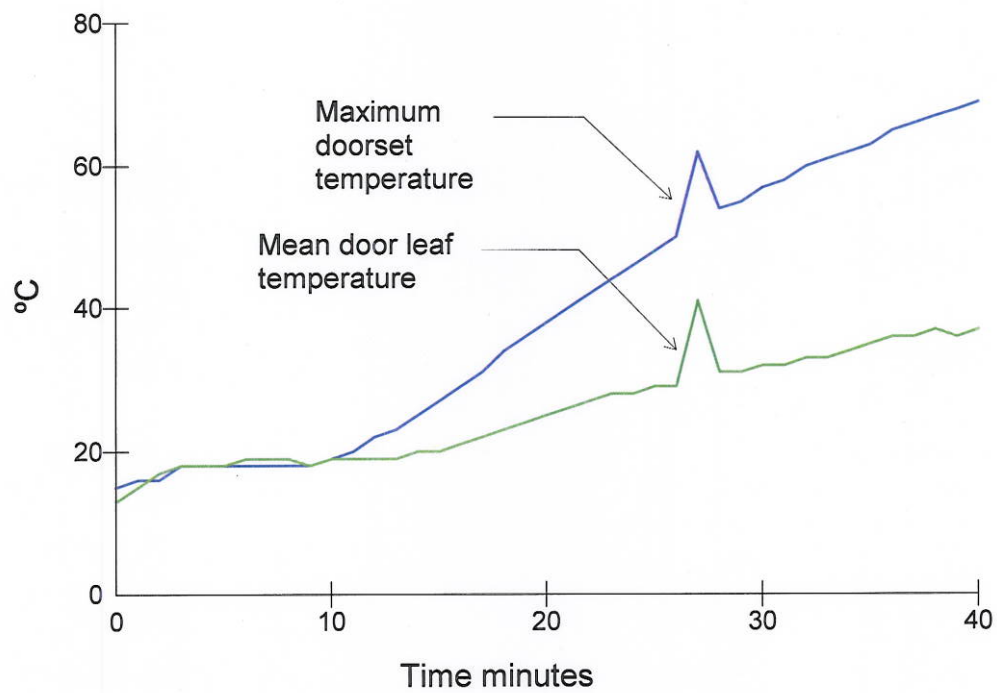
The temperature of the unexposed face was monitored by means of the following thermocouples:

Doorset	2 discrete areas	
Leaves	Discrete area 1 (timber)	5 measuring mean temperature rise.
	Discrete area 2 (glass)	1 measuring mean and maximum temperature rise.
Frame	4 measuring maximum temperature rise.

The location of the thermocouples are shown in Figure 6 of Appendix 2. The temperatures recorded have been tabulated in Appendix 1 and are shown graphically below:

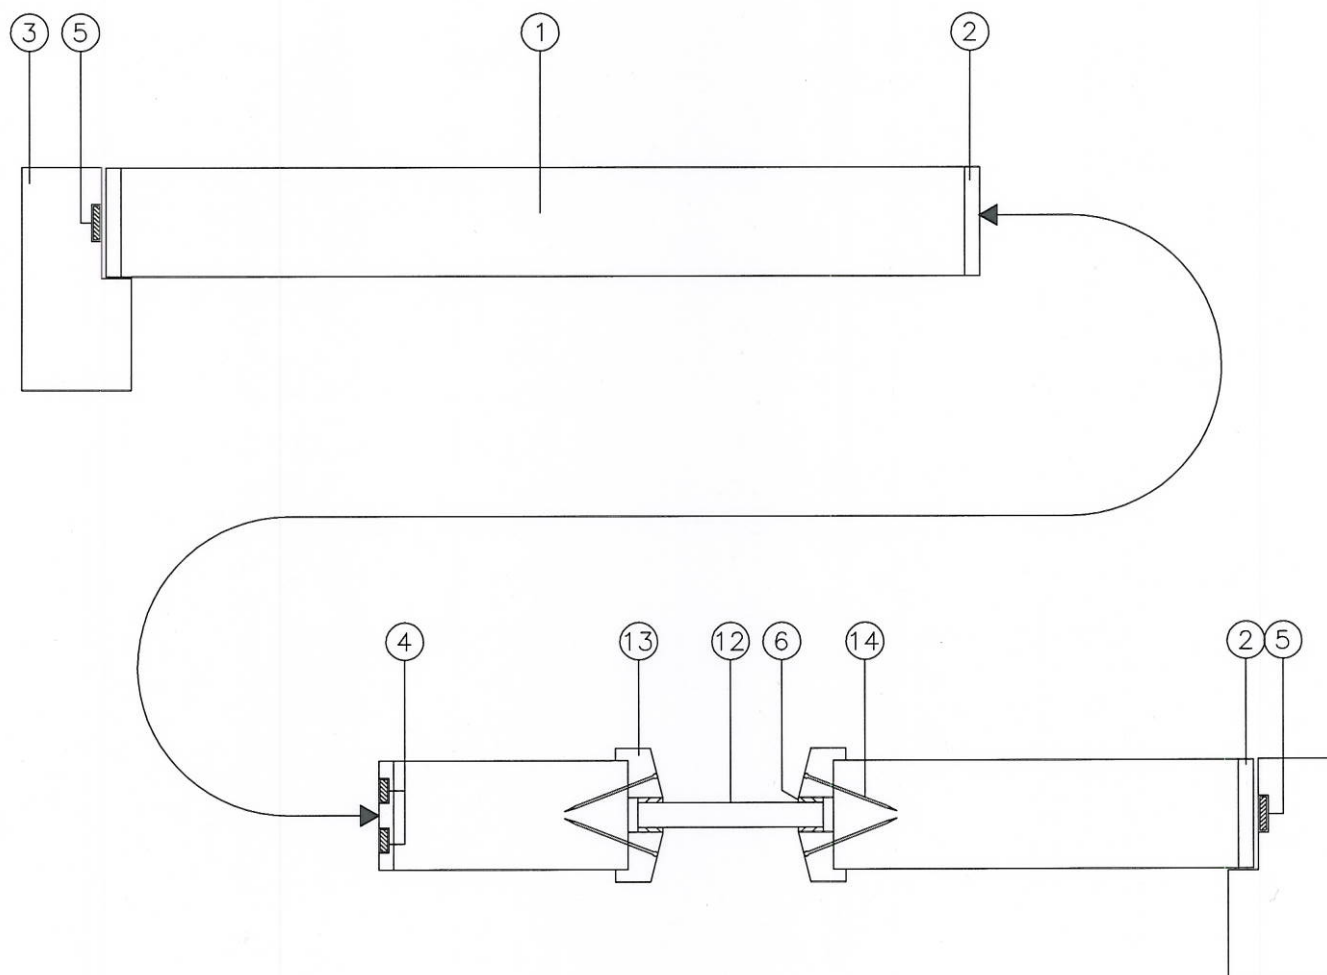
Horizontal cross sections

Section A-A

Species/type	Dimensions (mm)	Density (kg/m ³)	Moisture (% w/w)	Key to figures
Stiles and rails	None fitted	-	-	-	-
Core	Halspan FD30	44 thick	640**	10.2	1
Facings	None fitted	-	-	-	-
Adhesive	Lipping	Cascamite	-	-	-
Lippings – all edges	Sapele	6 thick	640**	11.5	2

Species/type	Dimensions (mm)	Density (kg/m ³)	Moisture (% w/w)	Key to figures
Head & jambs	European Redwood	90 deep x 44 wide including integral stop	510**	12.5	3
Stops	Integral	12 deep x 45 wide	-	-	-
Architrave	European Redwood	18 thick	-	-	-
Threshold	None combustible	-	-	-	-
Frame fixings	Steel wood screws @ 6-800 centres	No 10 x 80 long	-	-	-
Frame fire stopping	Mann McGowan Fabrications Ltd Pyromas intumescent acrylic mastic	Nominally 5-10mm wide x 10-15 deep	-	-	-

Make/type	Size (mm)	Location	Key to figures
Door edges	Vertical edge – right leaf only	2No Mann McGowan Pyrostrip 500 FP5A	10 x 4	Fitted centrally, 10mm apart on the meeting edge of the right leaf	4
Frame reveal	Head and jambs	Mann McGowan Pyrostrip 500 FP5A	15 x 4	Fitted centrally in the frame reveal	5
Around hinges		Fully interrupted	-	Hinge blade fully interrupts seal on frame	-
Under hinge blade		Mann McGowan Pyrostrip 300 ISA	1 thick	Fitted under the hinge blades on frame and jamb	-
Encasing latch body		Mann McGowan Pyrostrip 300 ISA	1 thick	Fitted around the body of the latch	-
Under latch forend		Mann McGowan Pyrostrip 300 ISA	1 thick	-	-
Around latch keep		Partially interrupted	-	Latch keep partially interrupts both seals leaving 5mm of each continuous	-
Under latch keep		Mann McGowan Pyrostrip 300 ISA	1 thick	Fitted under the latch keep	-
Glazing perimeter		Mann McGowan Pyroglaze 30	10 x 2	Fitted between the glass and bead on both faces	6

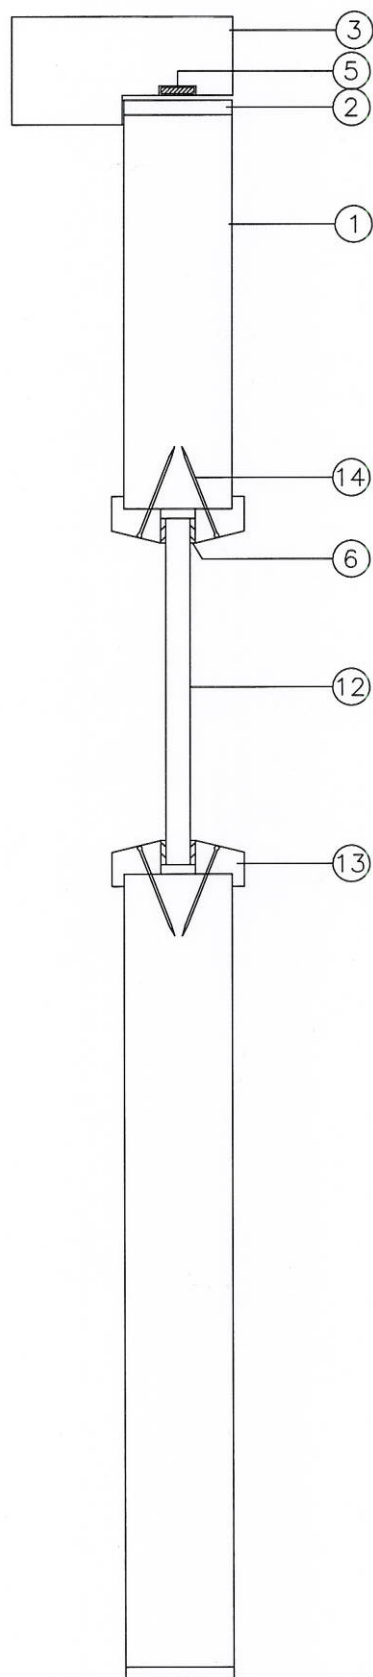
Vertical cross sections

Section B-B

Make/type	Size (mm)	Location	Key to figures
Glass type	Pilkington Pyrodur Plus	7 thick	Fitted 296mm from the head and 146mm from the meeting edge of the right hand leaf	12
Sight size	-	723 high x 221 wide	-	-
Overall aperture size	-	750 high x 250 wide	-	-
Expansion allowance	-	3 all round	-	-
Beading	Sapele (density 640kg/m ³ , m.c. 11.5%)	19 high x 20 deep with a 5 x 5 bevel return and a 14° chamfer	Fitted around the glazing aperture on both faces	13
Beading fixings	Lost head steel nails	40 long	Fitted 50mm from corners at 150mm centres	14

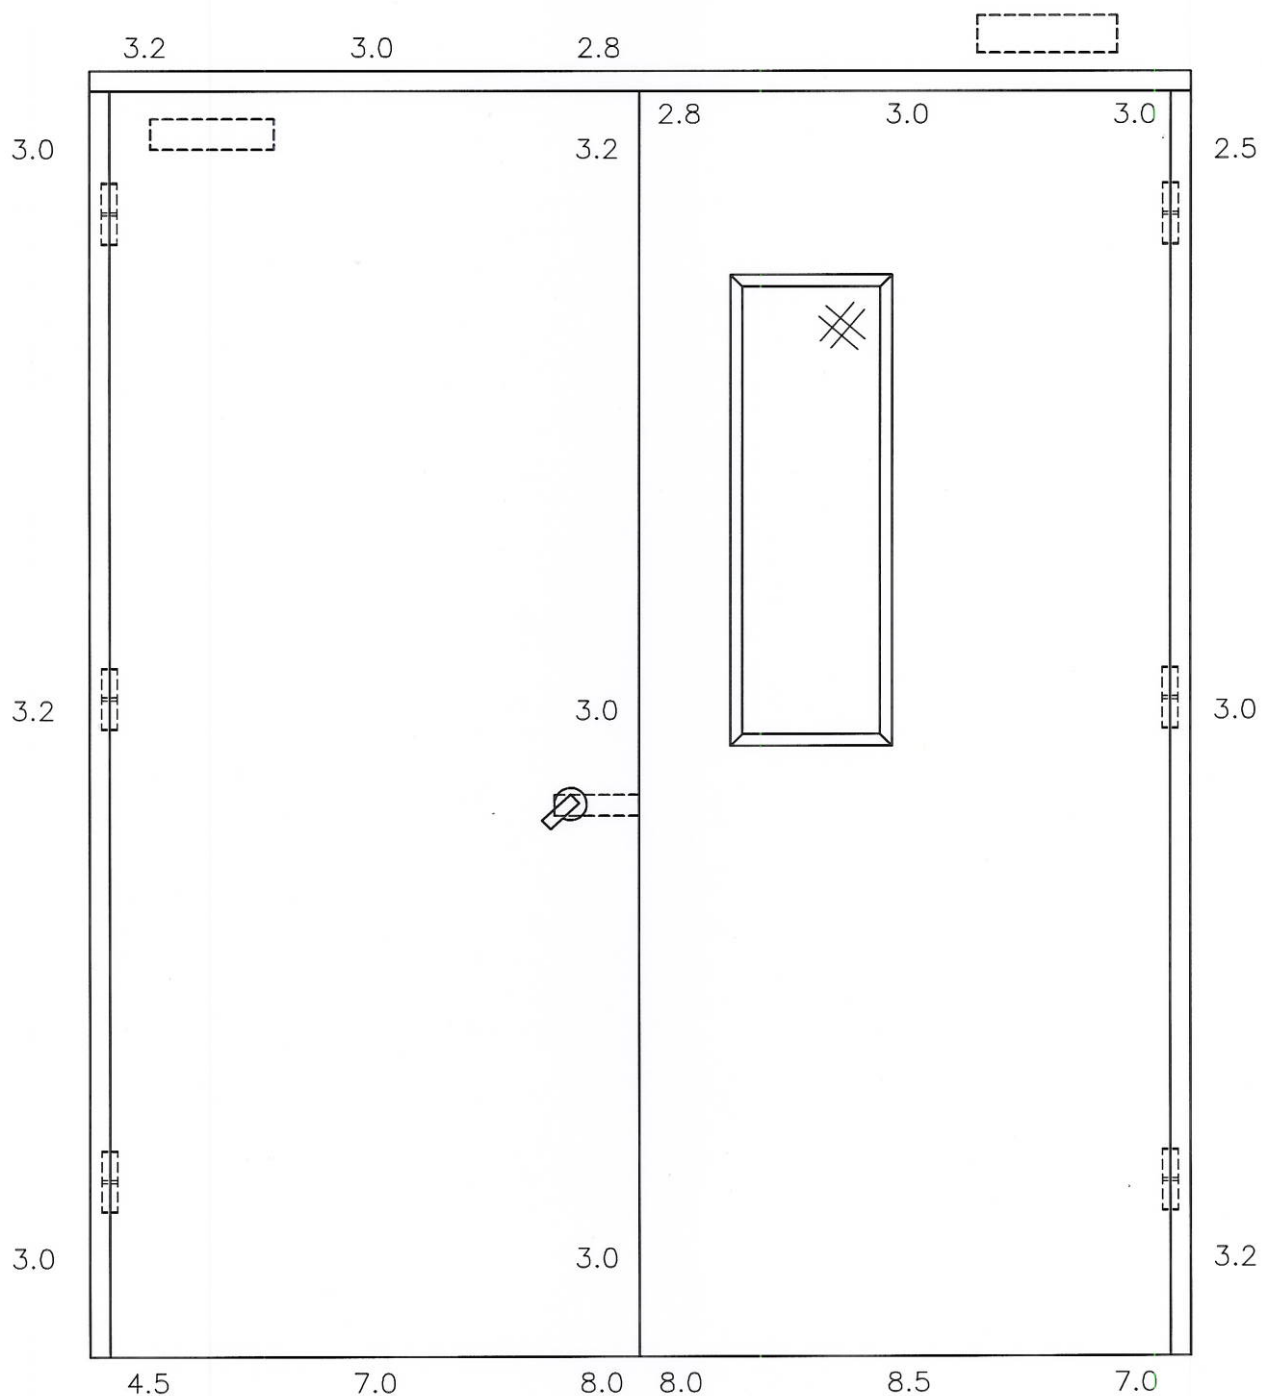
Door gaps

Gaps Shown

The manufacturer did not declare a working range so the doors were installed to open and close freely, maintaining gaps, where possible, to a range of 2-4mm. The gaps between the edge of the doors and frame were measured prior to test. A total of 21 readings were taken. The measurements (in mm) are given in Figure 5 of Appendix 2.

The results of this test were obtained using the door to frame gaps recorded in Figure 5 of Appendix 2. The fire resistance performance of doors of this design may change if substantially different gaps are employed.

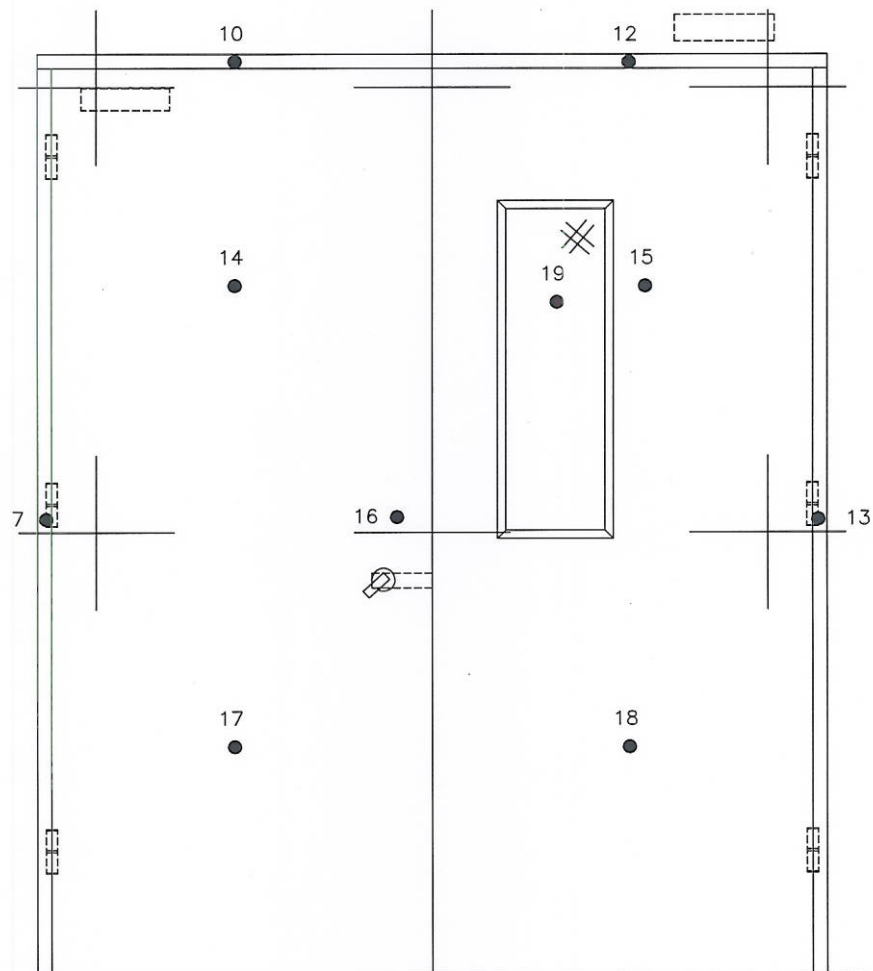
Thermocouple positions

+ : Furnace Thermocouples
 • : Unexposed Face Thermocouples

Viewed From Unexposed Face

(see Figure 6 of Appendix 2 for channel locations)
