#### Test Report : RF96095

**A fire resistance test performed on  
two single leaf single acting doorsets with various ironmongery**

**Test conducted in accordance with BS 476 : Part 22 : 1987**

**Test Date: 20 November 1996**

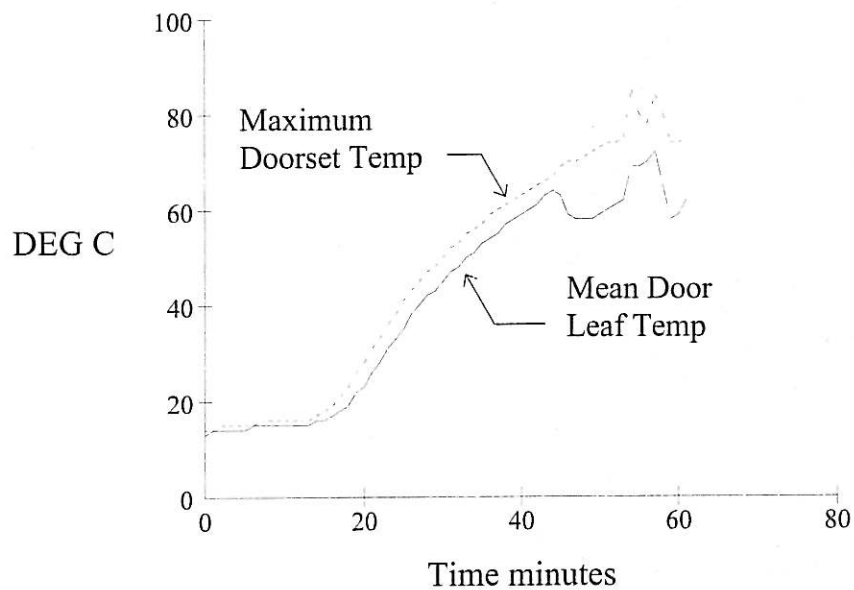
**FIGURE 2 UNEXPOSED FACE TEMPERATURE CURVES**

- 7.5 The temperature of the unexposed faces were monitored by means of five thermocouples fixed to the surface of the door leaves, and three thermocouples attached to each frame, one at midheight on each jamb and one centrally located above the leaf on the frame head. The thermocouple positions are shown in Figure 6. The average temperature of each door leaf and maximum temperature of each doorset are shown graphically in Figure 2.

**DOOR A**

**DOOR B**
